Technical Report CERC-94-6  
March 1994

## Rehabilitation of the South Jetty, Ocean City, Maryland

by *Gregory P. Bass*  
*U.S. Army Engineer District, Baltimore*

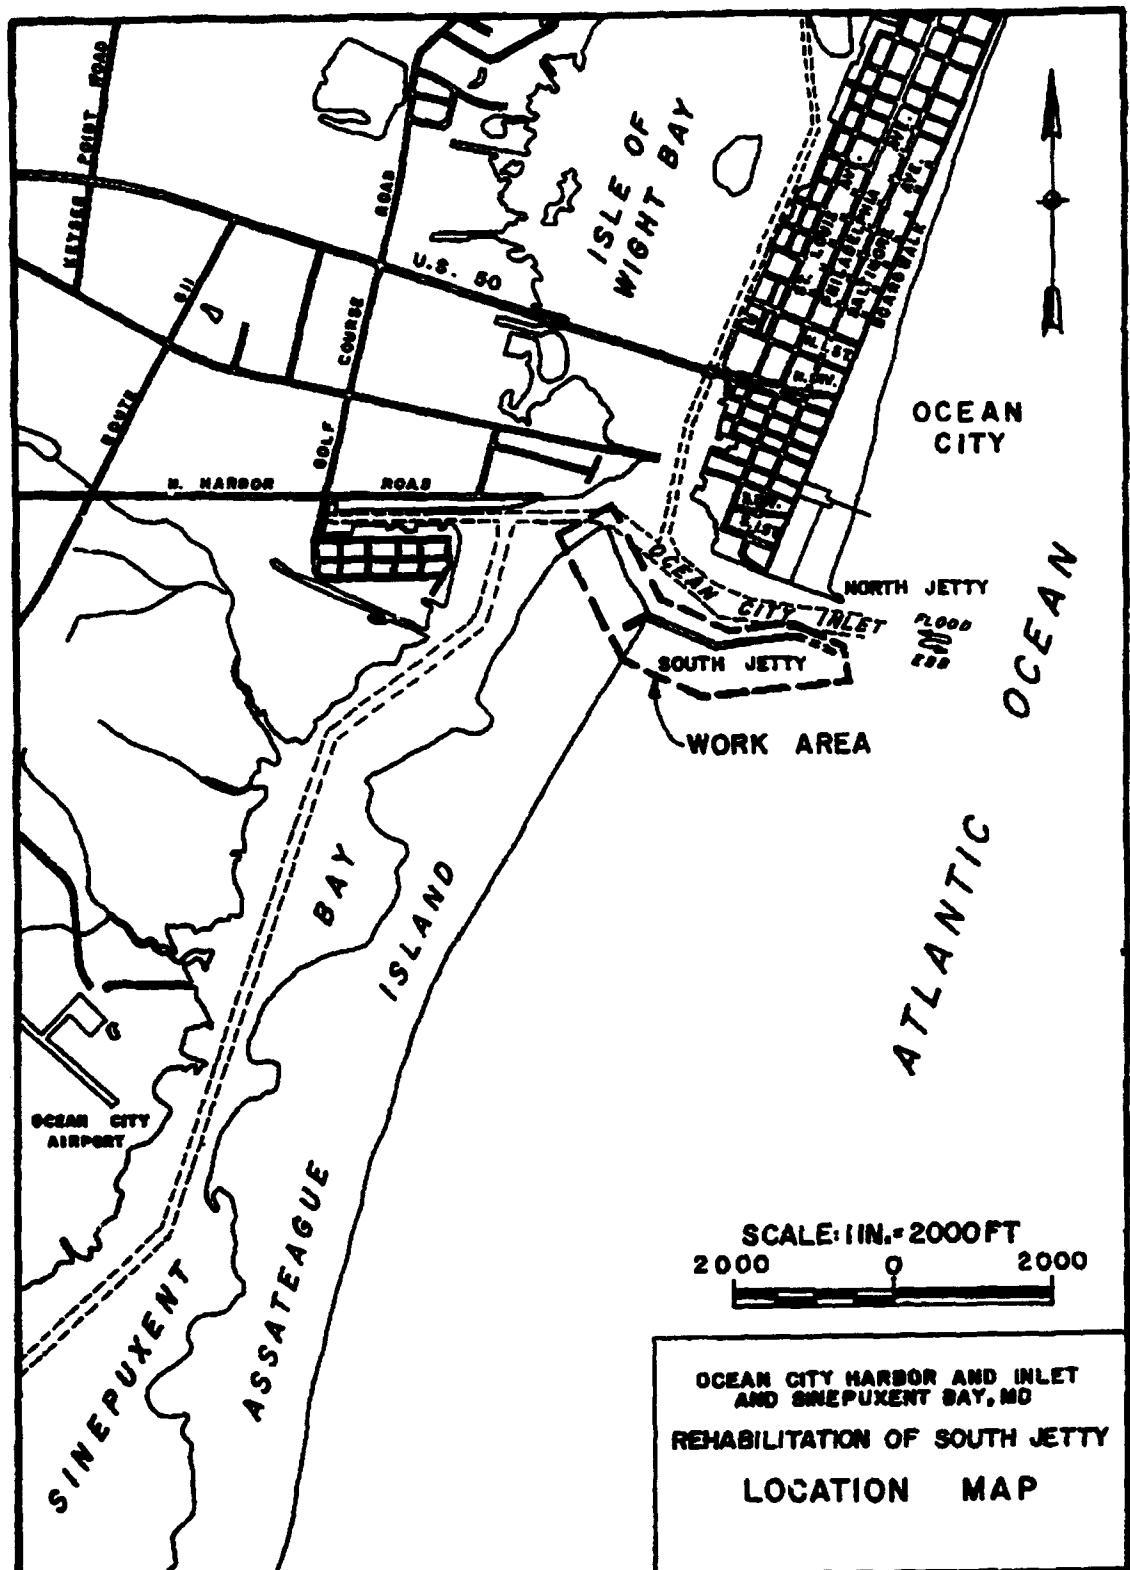
Figure 3. Location of the south jetty constructed in 1934

The south jetty was constructed in 1935 with a crest elevation of +4.7 ft NGVD. The inshore section of the south jetty paralleled the north jetty for a distance of about 750 ft at which point it trended towards the north jetty, decreasing the inlet width from 1,100 ft to 600 ft. At this point, the south jetty again paralleled the north jetty for a length of 530 ft. The first 170 ft of this 530-ft section had a crest elevation of +4.7 ft NGVD. The elevation of the next 160 ft of the south jetty decreased from +4.7 ft NGVD to the elevation of the "apron" section which was 4 ft above the existing bottom. This apron section continued at this elevation for an additional 200 ft. Figures 4-6 show the condition of the inlet between 9 October 1934 and 6 December 1935.

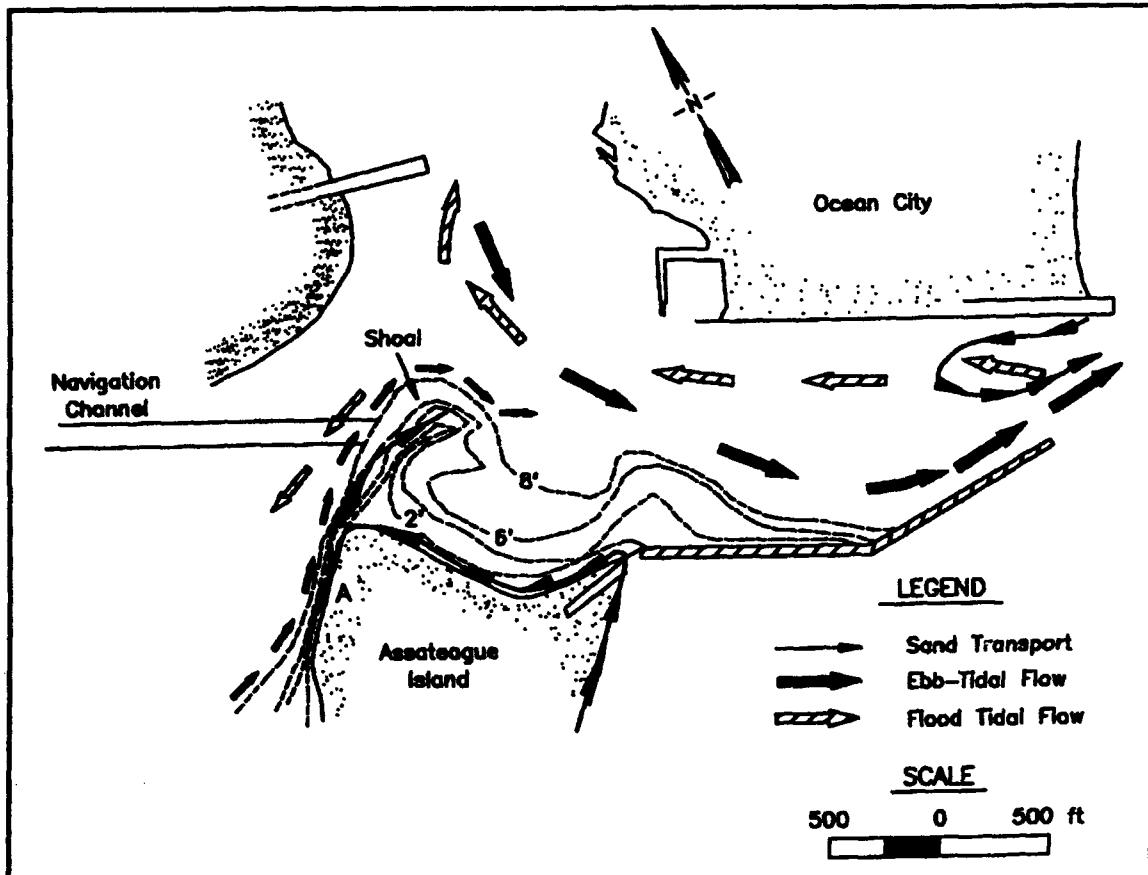
**Figure 8.** Schematic of the tidal currents and sand transportation patterns inside the inlet (Dean and Perlin 1977)

jetty, significant quantities of sand were being transported northward along the shoreline of Assateague Island, and then through and over the nearshore section of the jetty. This sand eventually was being deposited inside the inlet, temporarily stored on the north end of Assateague Island, and then transported north by ebb currents encroaching on the existing Federal navigation channel, as shown in Figure 8.

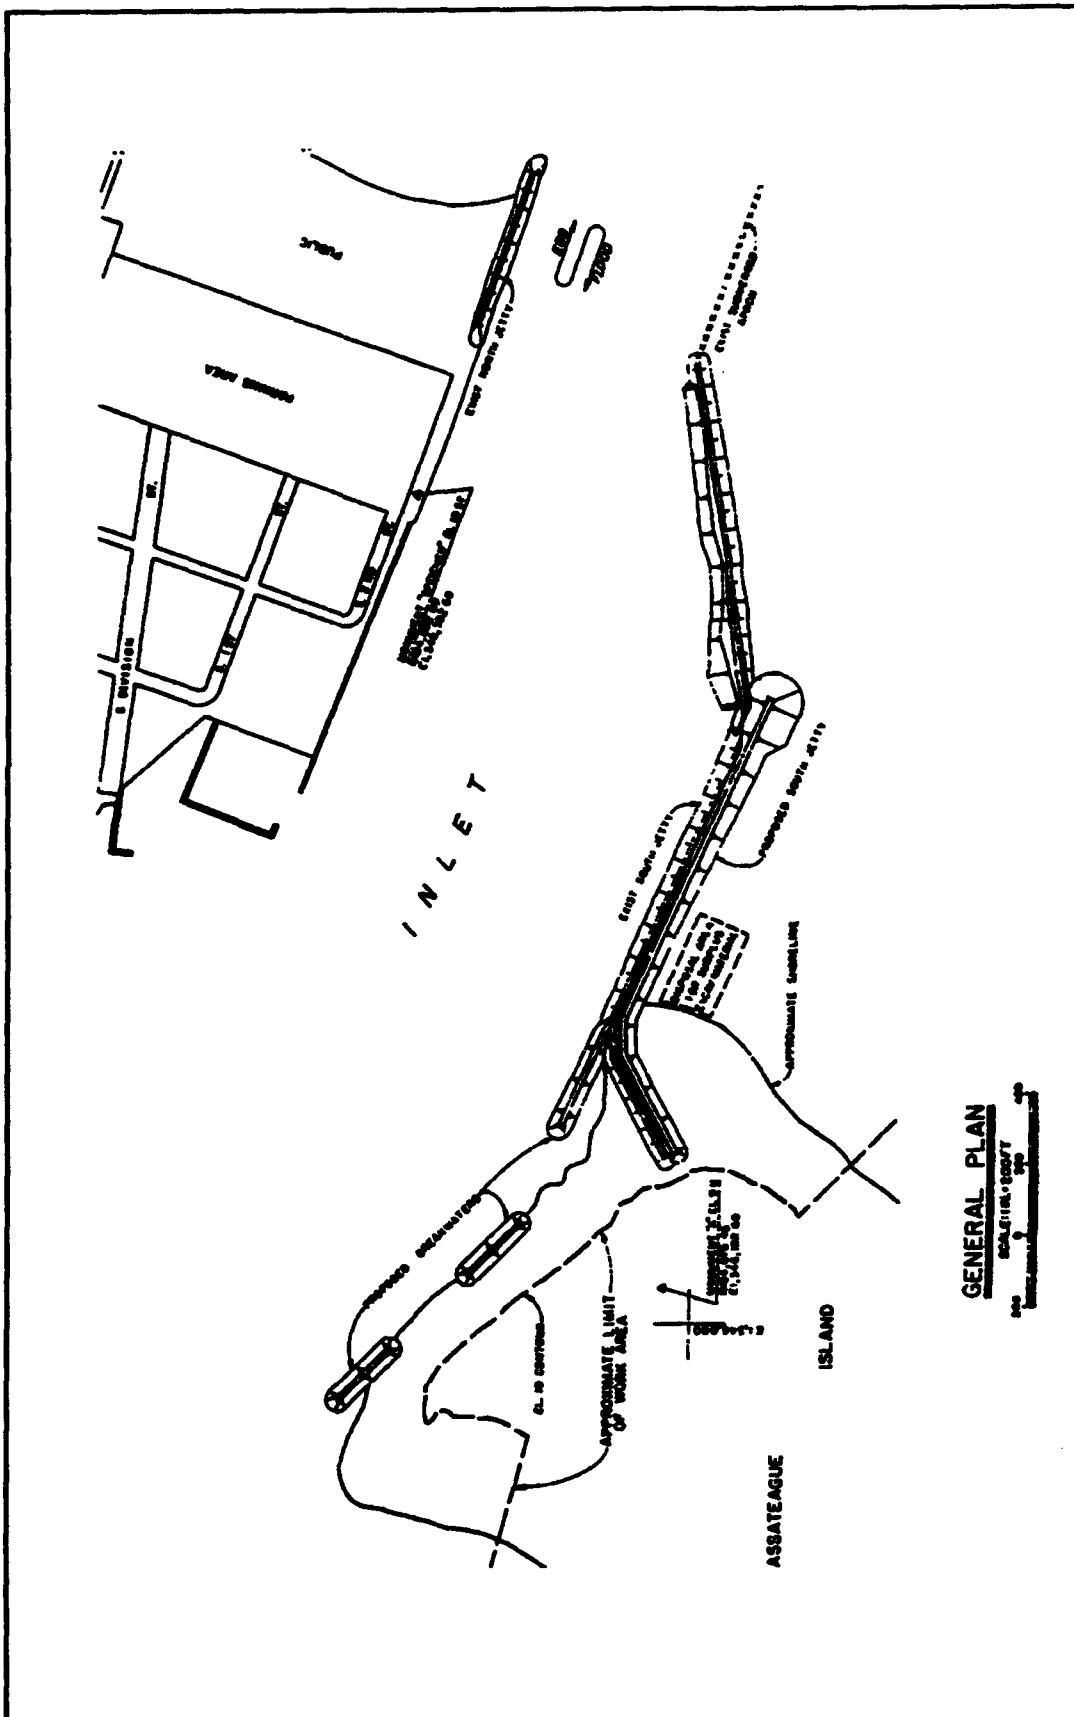
Figure 9. Plan view of the reconstructed south jetty

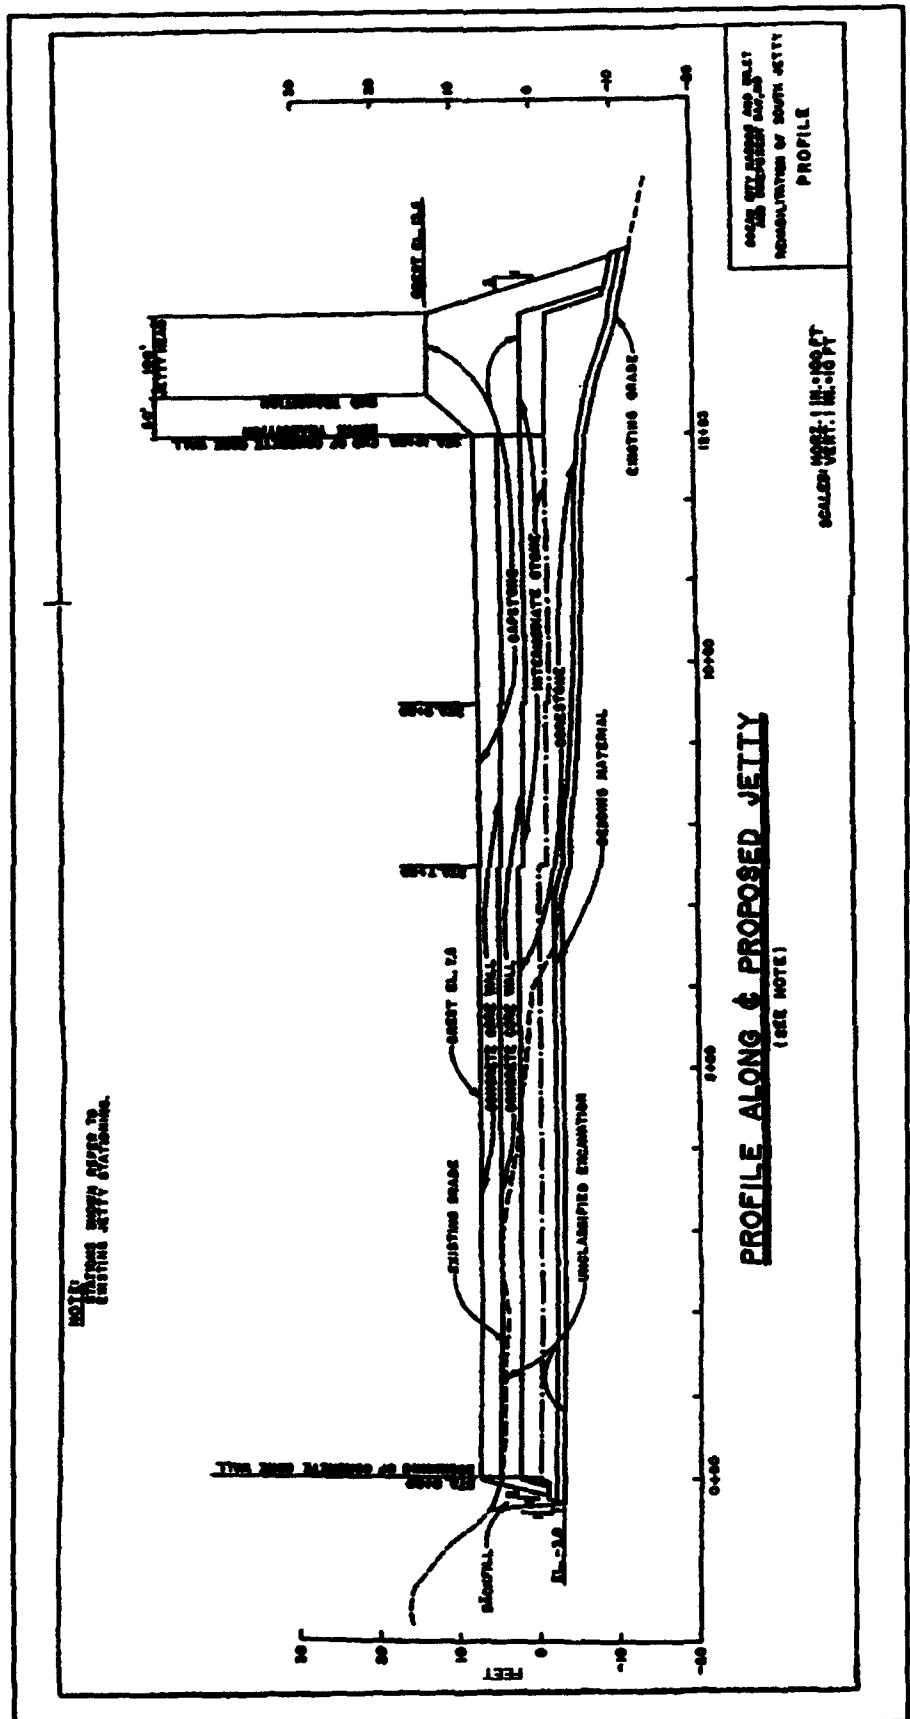
Figure 10. Profile of the reconstructed south jetty

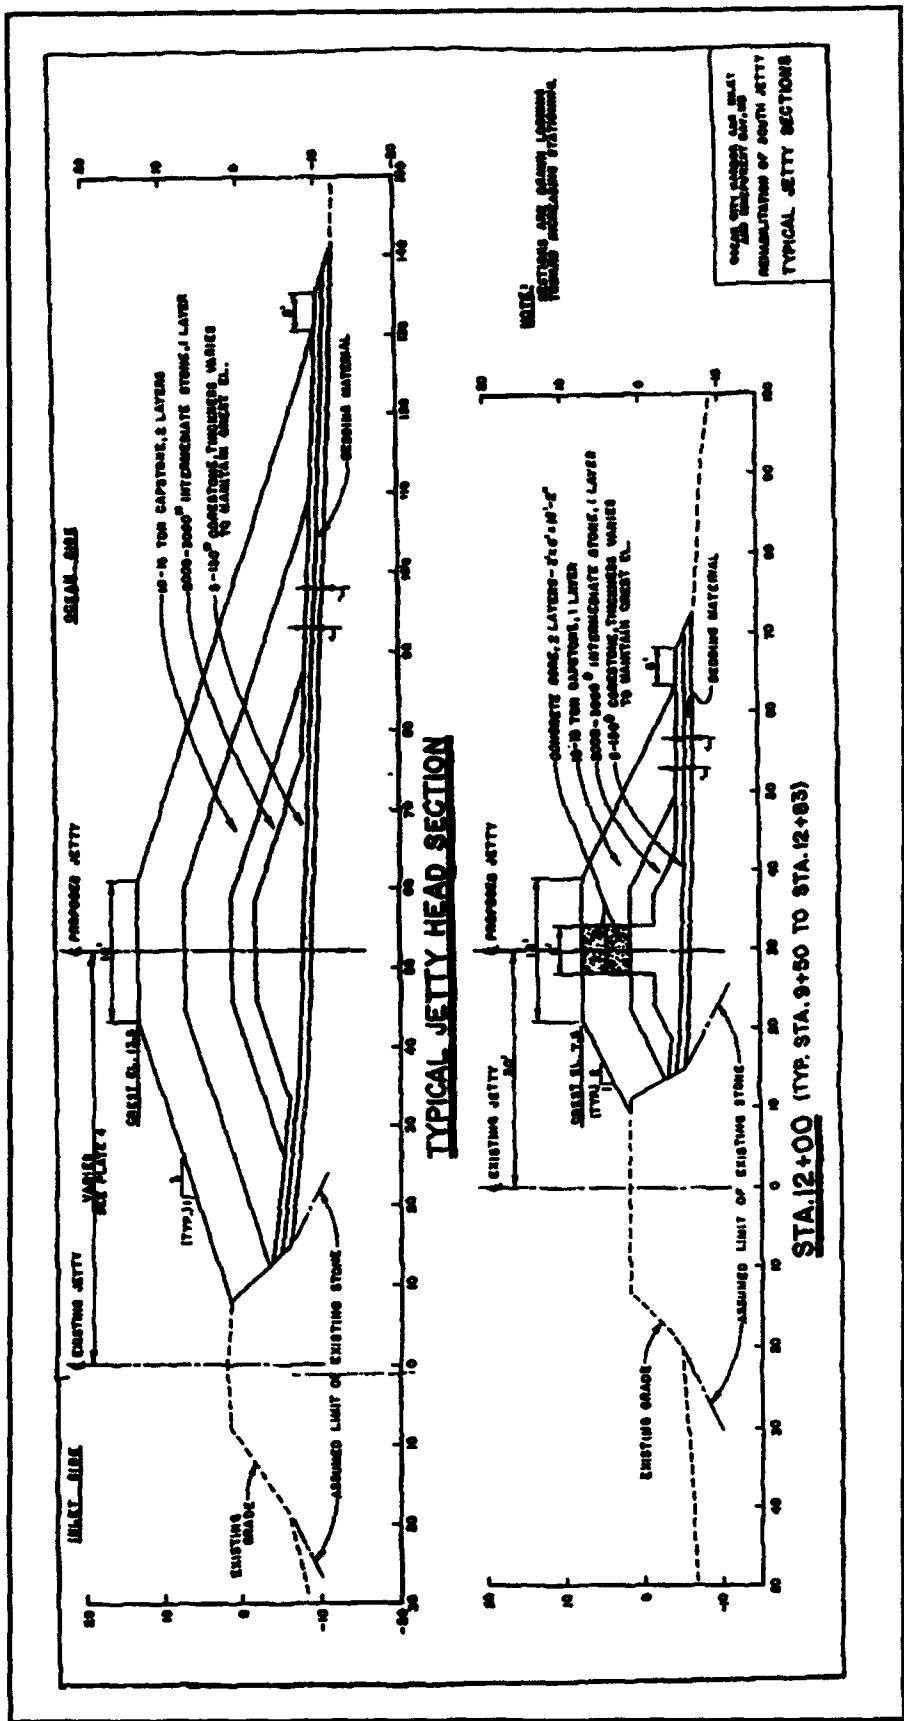
Figure 11. Typical cross-section of the reconstructed south jetty, elevations in feet (NGVD)

underlayer widths required for stability under design wave conditions. A crest width equal to the combined widths of three capstone widths was selected for the jetty. These crest widths ranged between 16 and 18 ft.

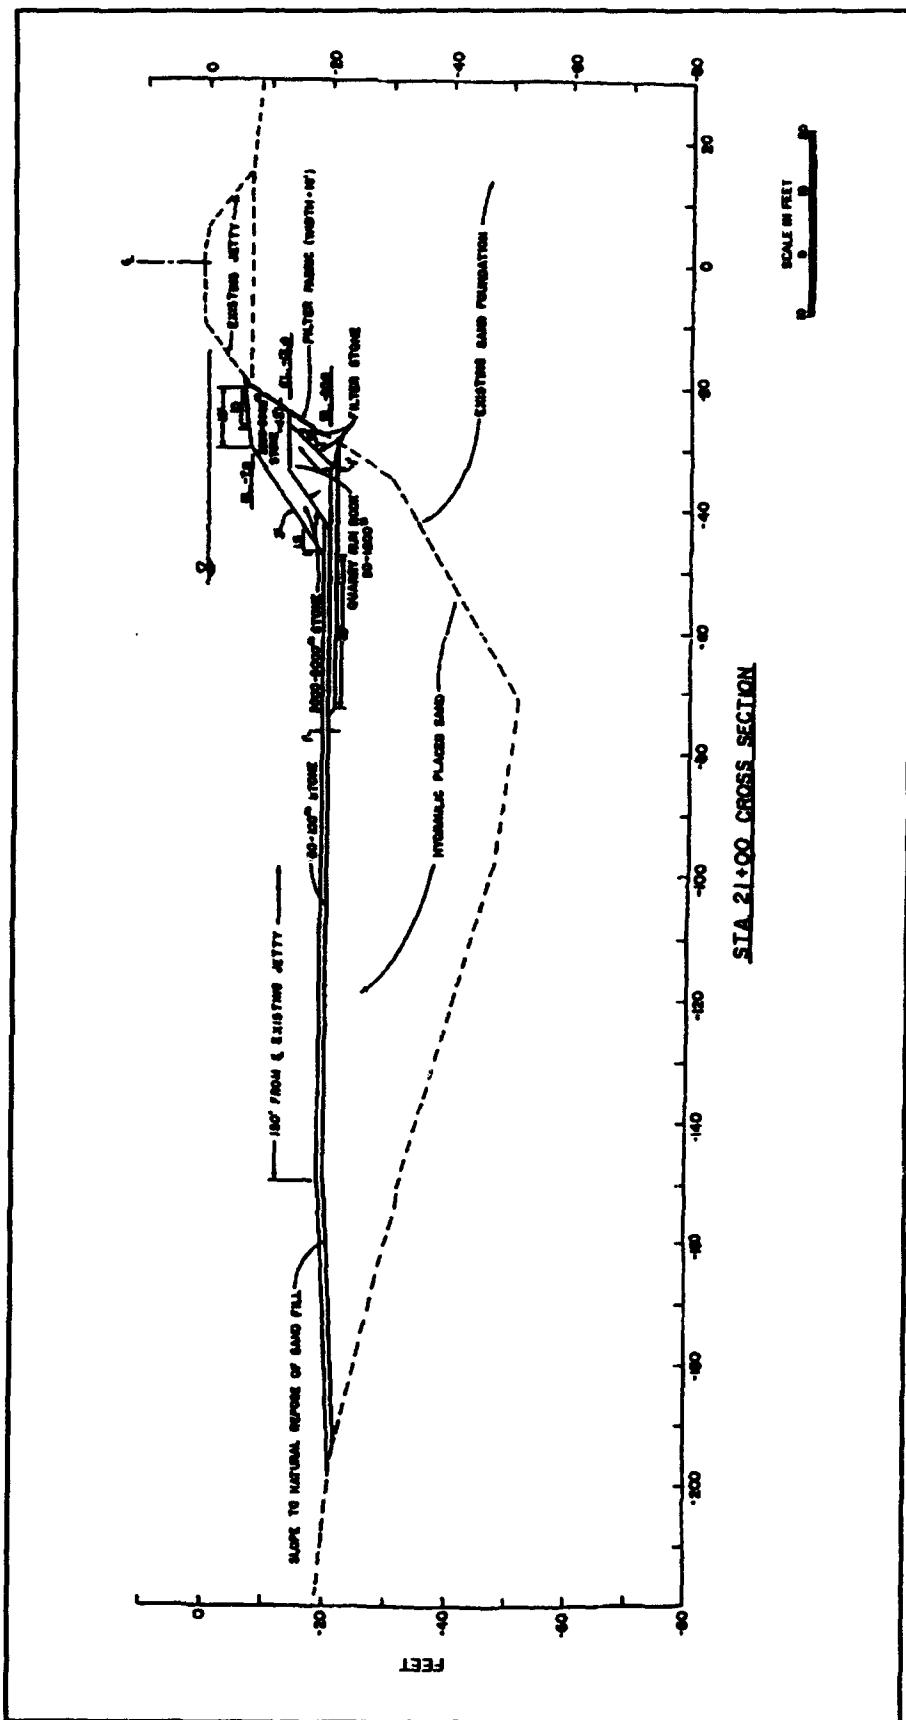
Figure 12. Cross-section of the filling in on the scour hole and placement of pound stone

To prevent this failure, the scour hole was filled with sand hydraulically, as shown in Figure 12, to elevation -30.0 ft NGVD and then armored with a protective blanket composed of several layers of 50- to 200-lb stone. The elevation of the fill was limited to -30 ft NGVD, instead of the original design elevation of -20.0 ft NGVD, to facilitate construction. In addition, an armored stability berm was placed on the inlet side of the jetty from sta 14+50 to sta 23+00. These features are shown in Figure 12.

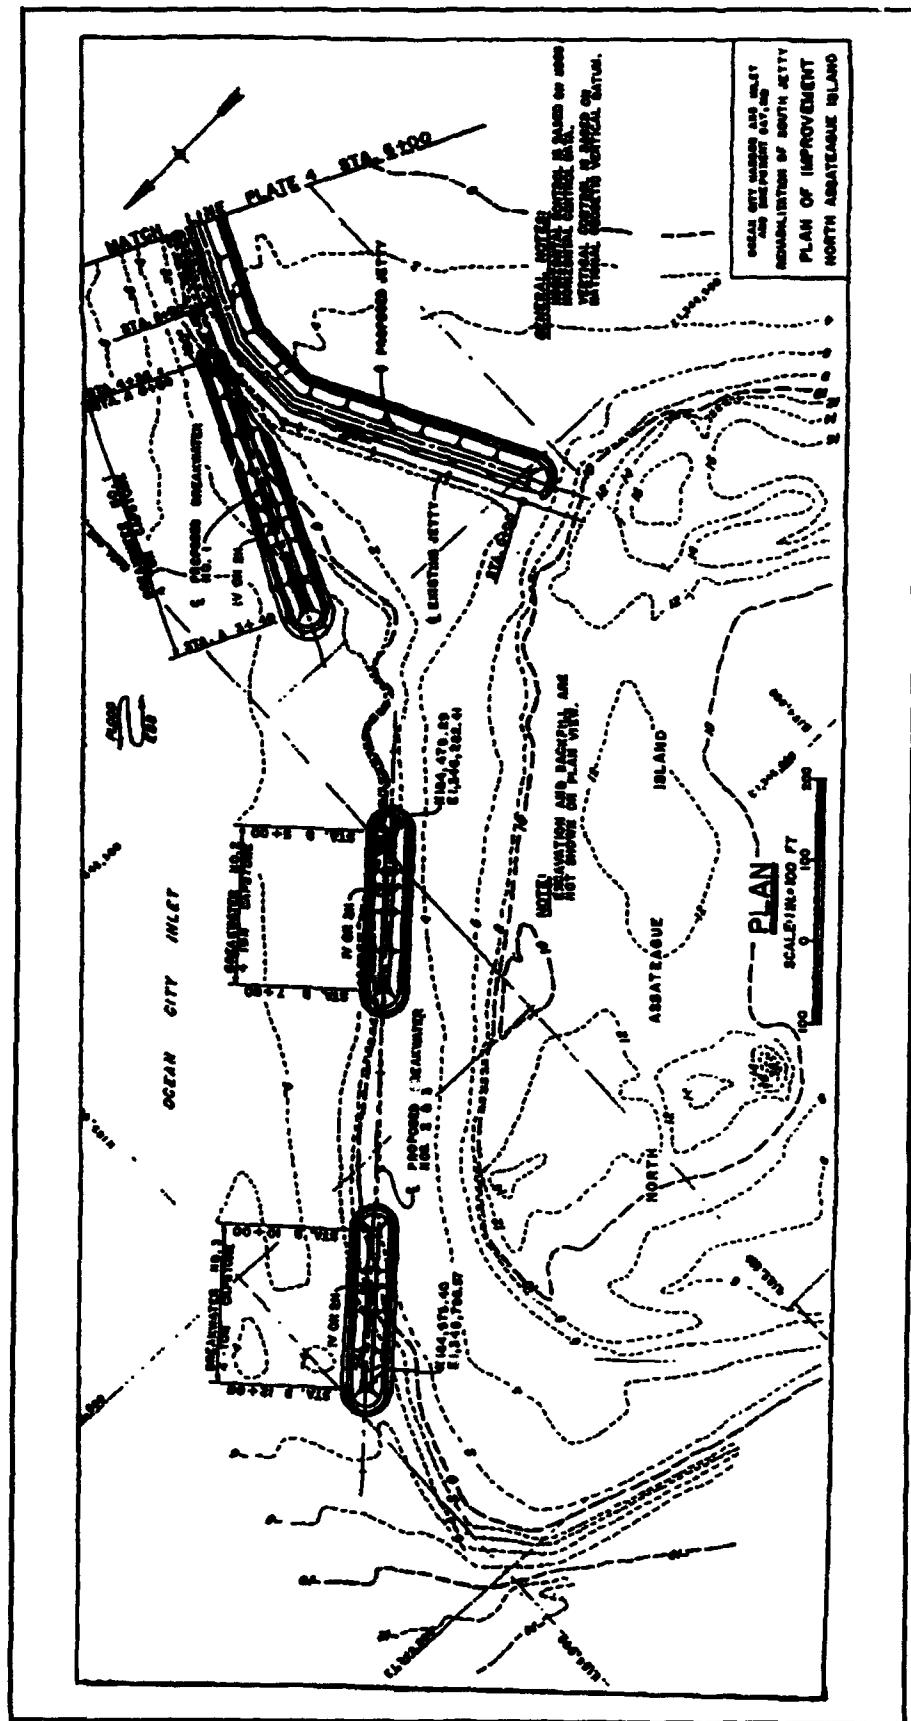
Figure 13. Plan view of the three breakwaters constructed to protect the northern end of Assateague Island

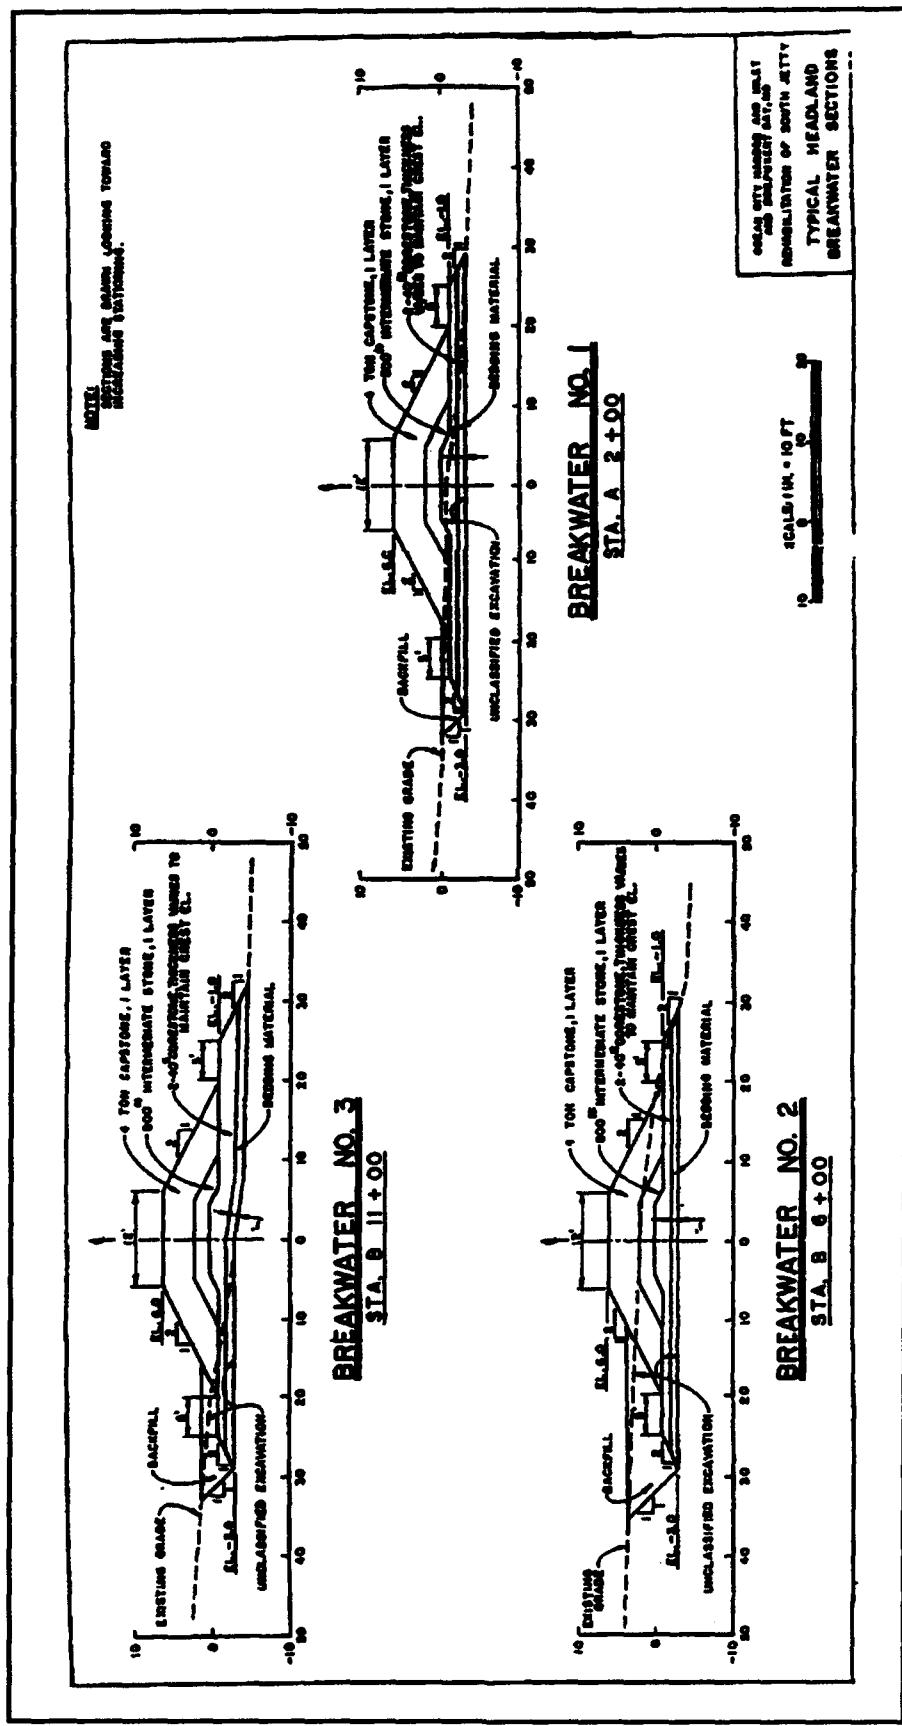
Figure 14. Typical cross-section of the breakwaters

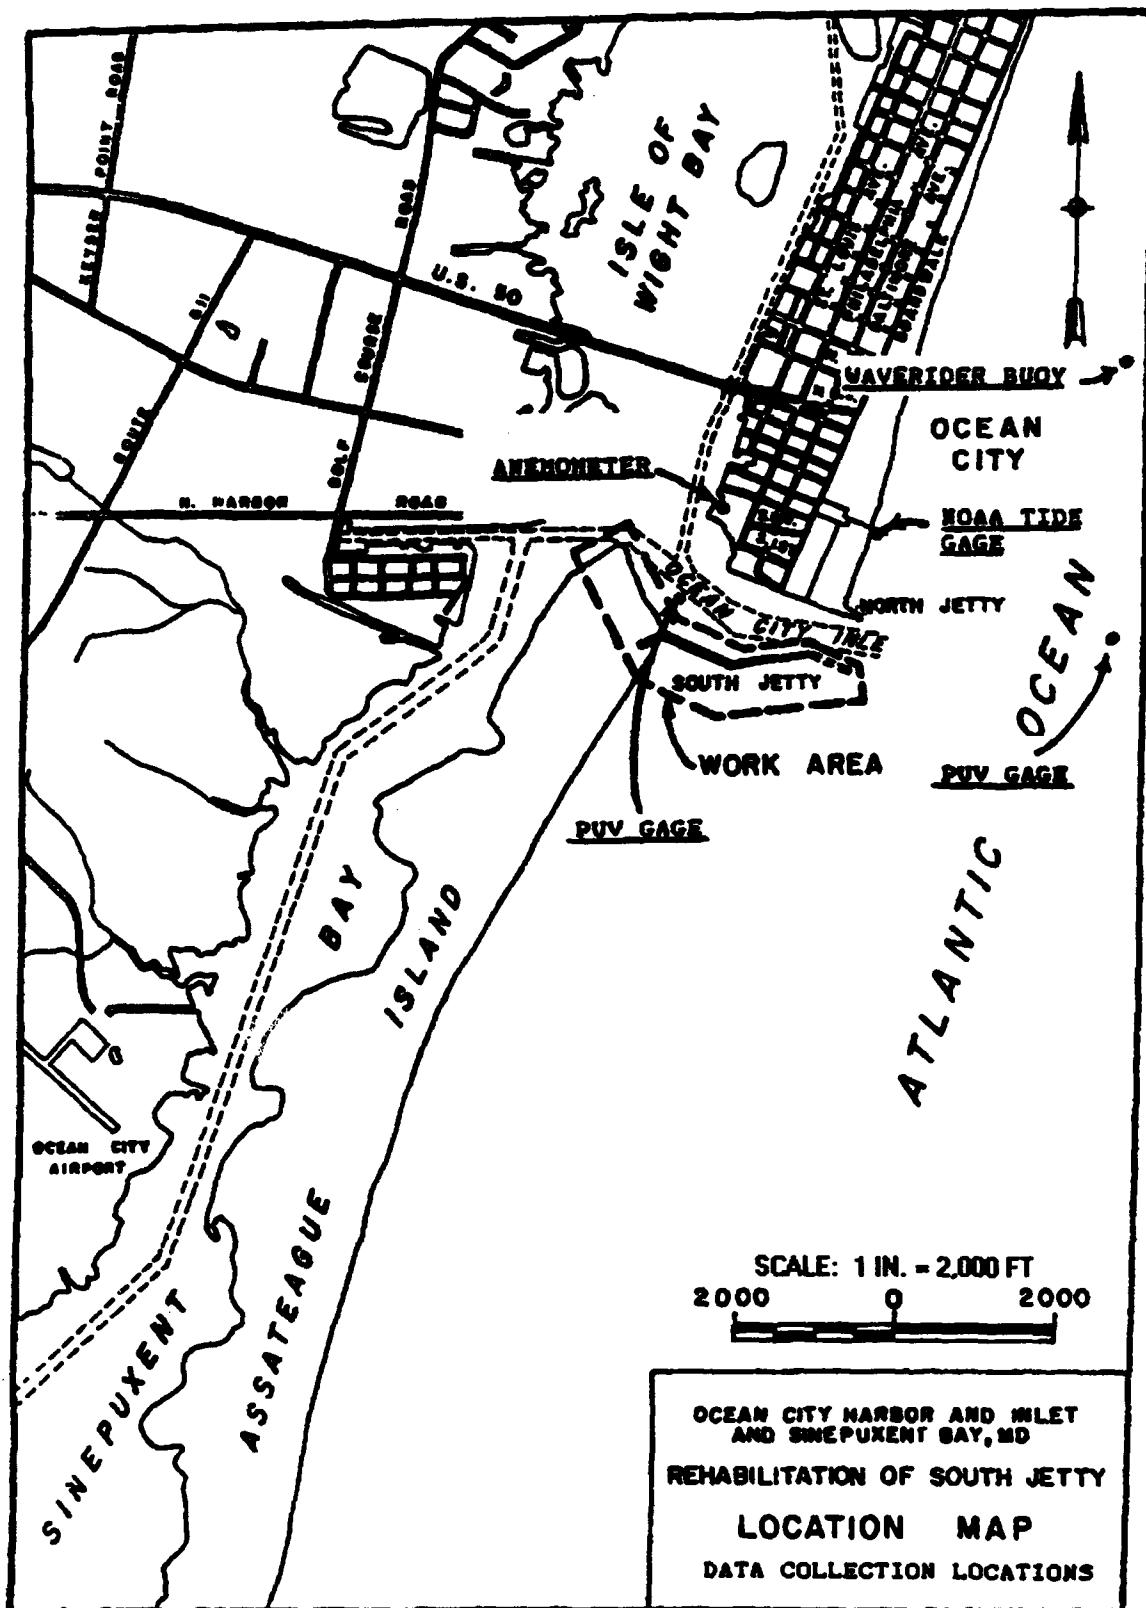
Figure 15. Location of data collection instruments used in study

Deepwater wave data (nondirectional) were obtained during the monitoring program with a Datawell Waverider buoy located in about 50 ft of water northeast of the south jetty as shown in Figure 15. Due to prohibitive winter weather conditions, the deployment of the Waverider buoy was delayed until 2 April 1986. A shore-based receiver station was established in the Ocean City Life Saving Museum located at the southern end of the boardwalk. Wave data transmission from the Waverider buoy to the receiving station was initiated and continued until 6 November 1987. From 2 April to 6 November, 18 days of downtime due to communication problems were encountered. Between 12 September 1986 and 4 December 1986, the Waverider buoy was inoperable due to malfunction of the shore-based receiver. On 4 December 1986, the buoy resumed operation and provided wave data until 23 January 1987. The gauge was lost sometime between the end of January and the end of February 1987 and has not been recovered.

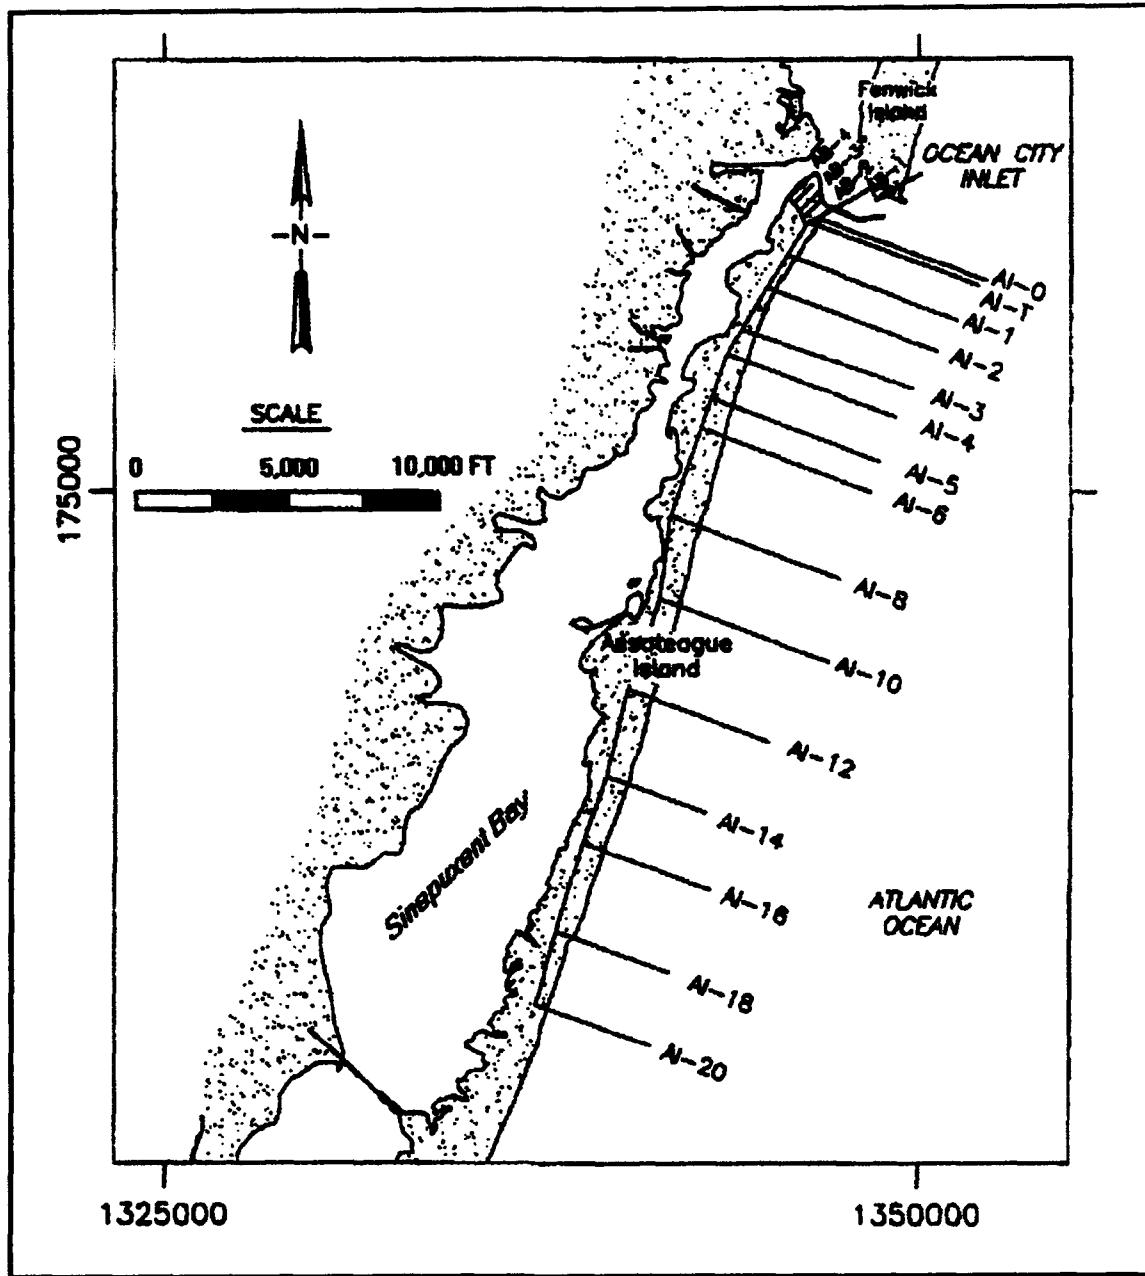
**Figure 16. Location of the 19 profile sites monitored**

Fifteen beach profiles shown in Figure 16 and listed in Table 2 were surveyed out to the -30-ft NGVD contour (where applicable) in order to capture depth of closure. During 16-23 May 1986, a horizontal and vertical control survey for the offshore profiles along the northern end of Assateague Island was completed. Surveys of the profiles were conducted on the following dates:

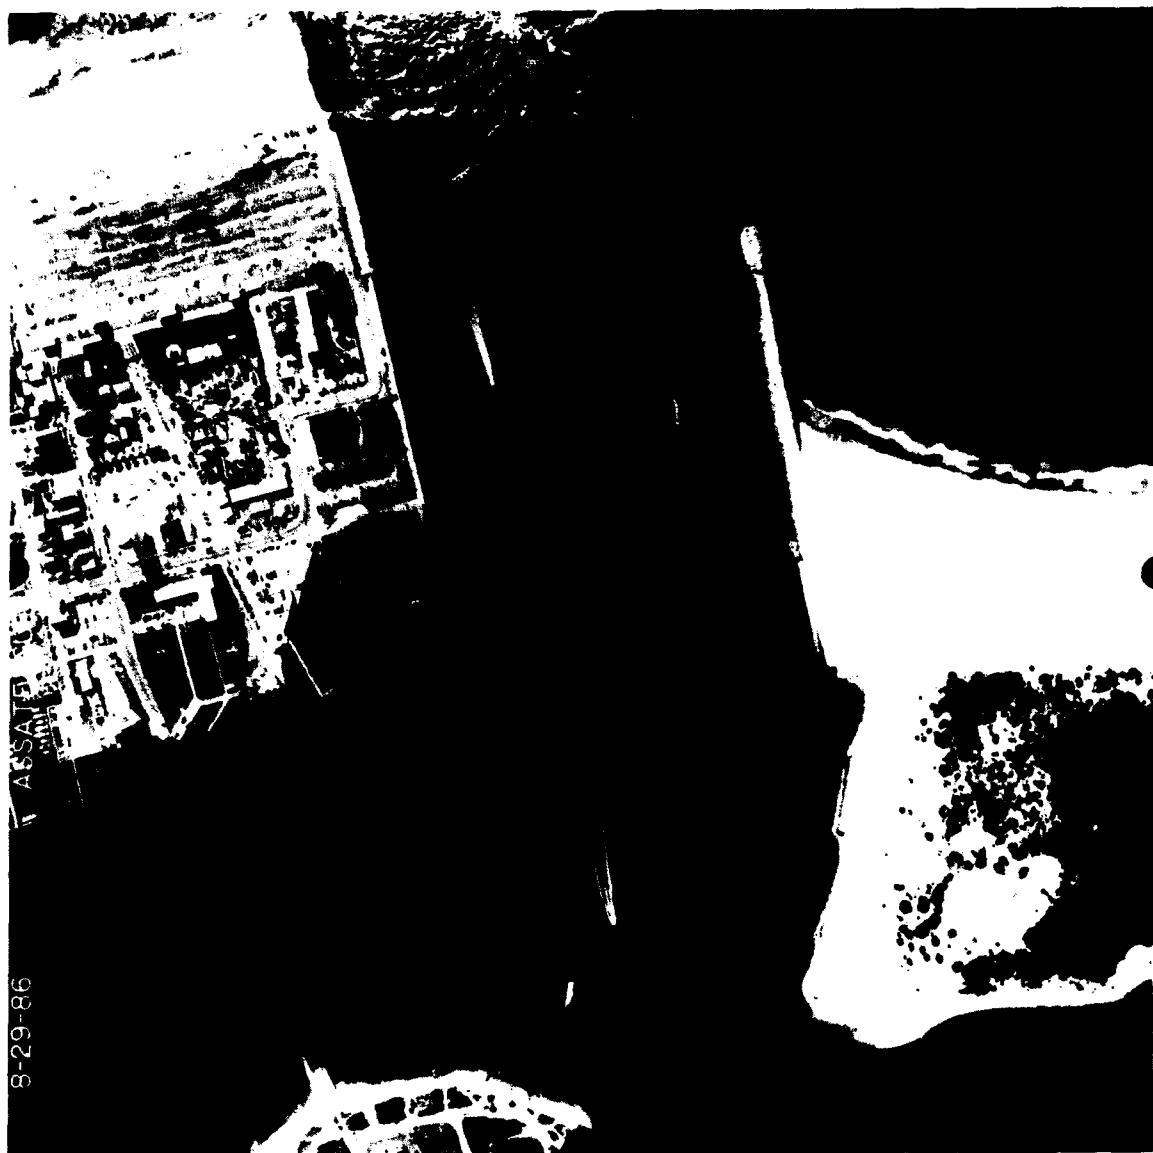
Figure 17. Condition of inlet on 29 August 1986 after the jetty reconstruction showing no indication of the reoccurrence of the shoal

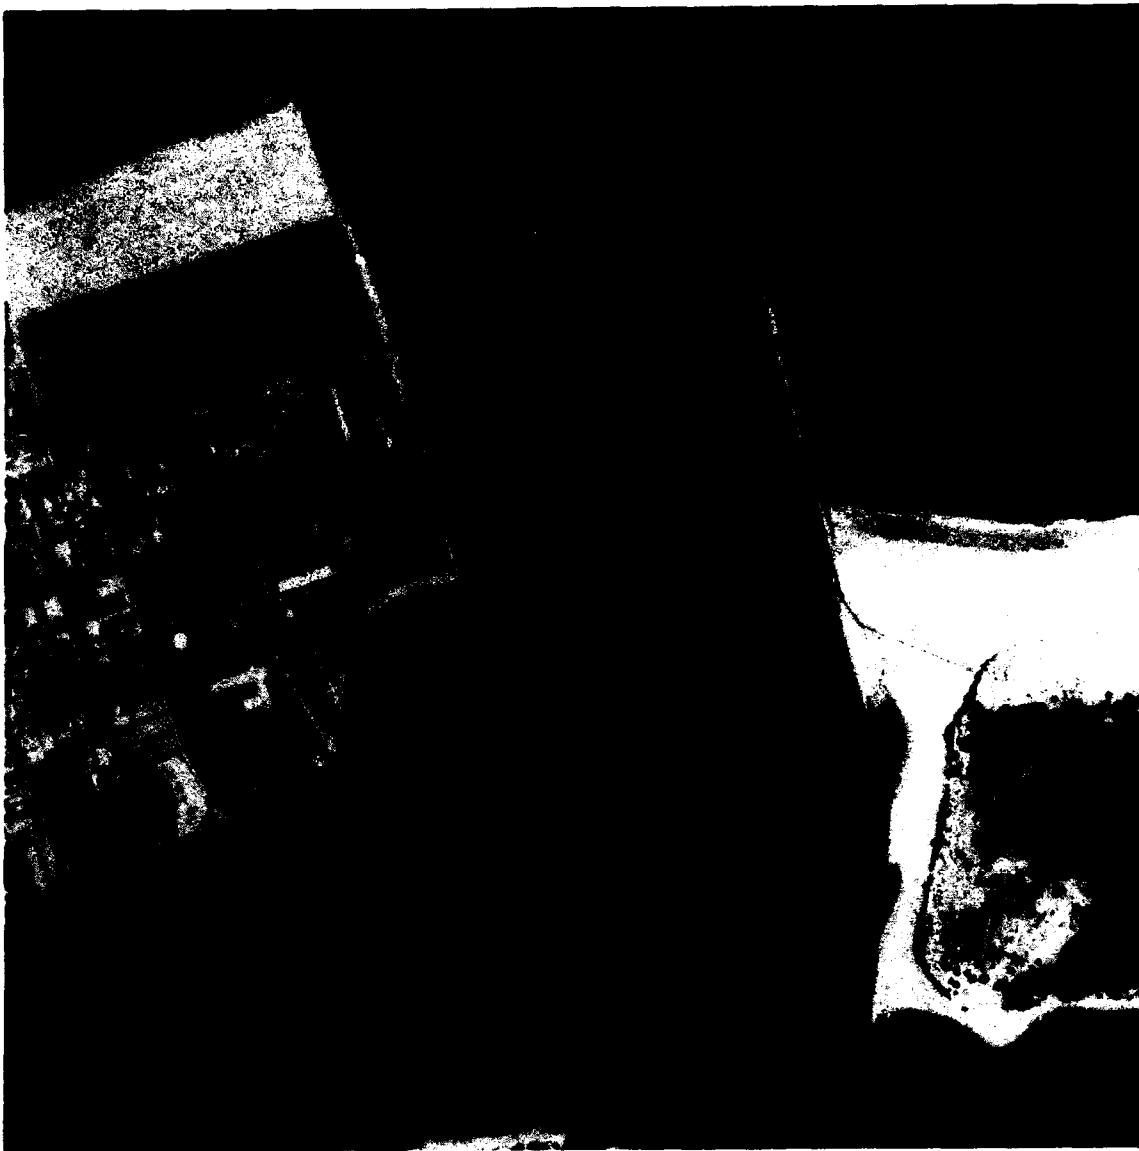
**Figure 18.** Location of the inlet on 23 December 1987 showing no indication of the reoccurrence of the shoal

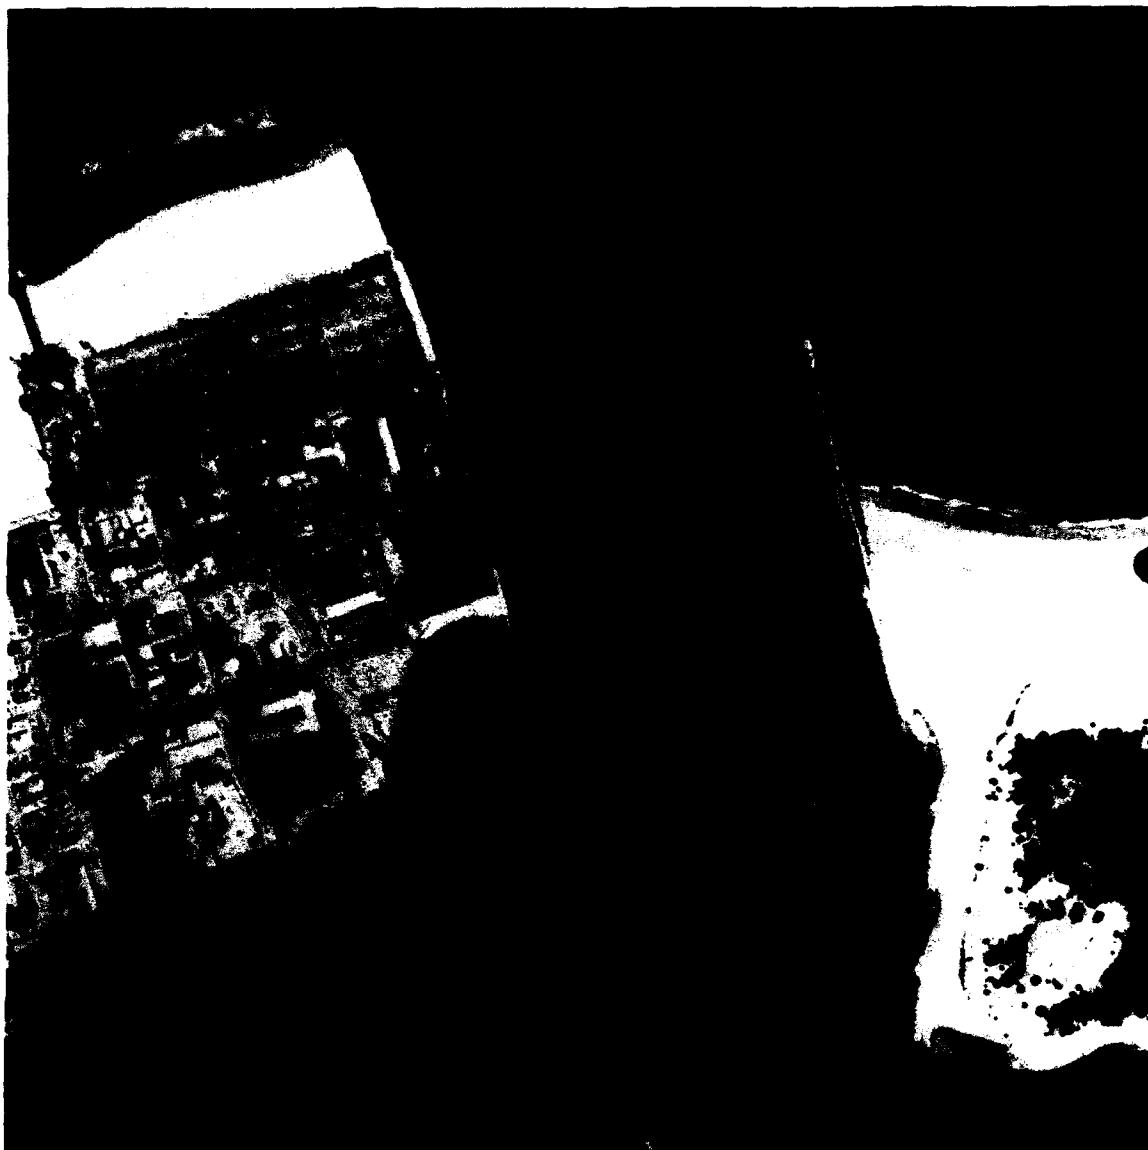
**Figure 19. Condition of inlet on 9 April 1989 showing continued erosion of the northwest shoreline**

Analysis of aerial photographs taken on 9 April 1989 and 21 February 1990 (Figures 19 and 20, respectively) indicates that the northwest shoreline segment continued to erode and by the latter date had achieved somewhat of an equilibrium orientation similar to the planforms formed

between the headland breakwaters. The formation of a finger shoal first identified in the 9 April 1989 photograph is clearly shown in the 21 February 1990 photograph. This shoal apparently formed from the eroding shoreline caused by the ebb tidal currents that previously formed the problem shoal. However, the orientation of this shoal is aligned more to the east than the previous problem shoal, possibly due to the diffraction of the current around the end of Breakwater No. 3. Consequently, the shoal does not interfere with navigation into or out of West Ocean City Harbor. Based on the 21 February 1990 photograph, it appears that the shoreline leeward of Breakwater No. 3 is approaching an equilibrium orientation, and that continued erosion of the shoreline contributing to the shoal area is not likely. It is recommended that the shoal area be dredged during the

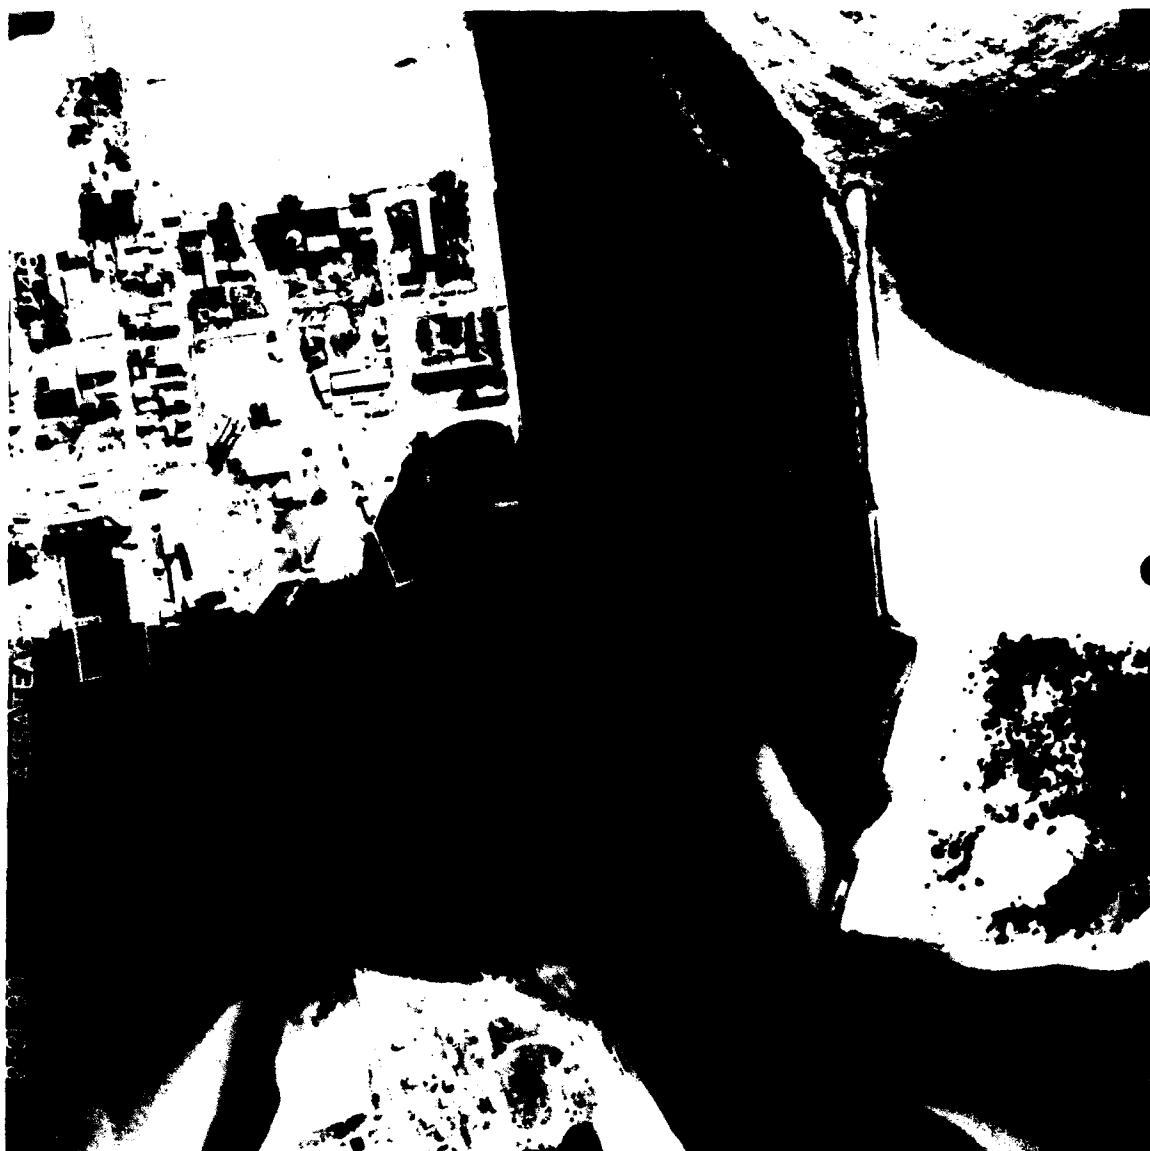
**Figure 20.** Condition of inlet on 21 February 1990 showing continued erosion of the northwest shoreline
